**US Army Corps
of Engineers®**
Engineer Research and
Development Center

Fluvial Instability and Channel Degradation of Amite River and its Tributaries, Southwest Mississippi and Southeast Louisiana

D. Ryan Hood, David M. Patrick, and Maureen K. Corcoran

September 2007

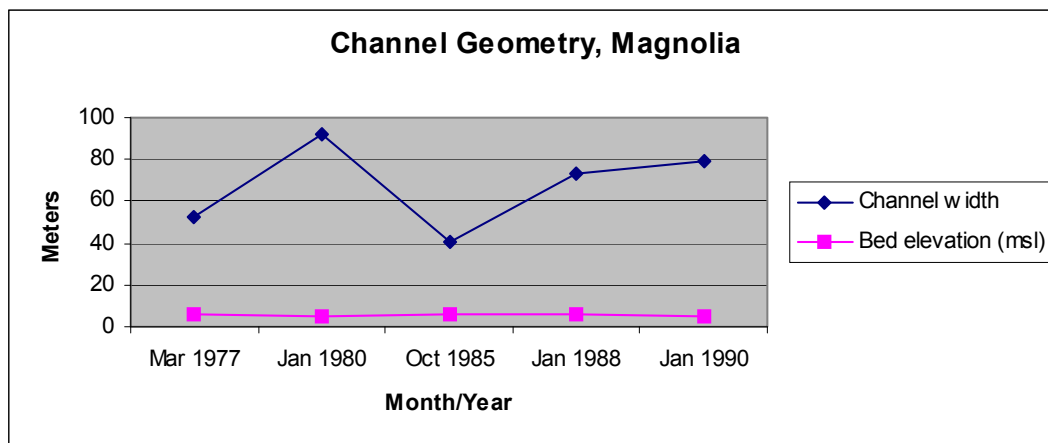
Figures 102 through 106 are plots of channel width and deepest channel elevation (thalweg) versus time at the five surveyed bridge crossing sites. In each plot, values of width and channel elevation are averaged for the three survey points upstream of the bridge. In general, each plot illustrates an increase in channel width. The increased channel width is more pronounced with distance downstream. Channel elevation, on the other hand, has remained mainly unchanged over time. Channel width change data are summarized in Table 1.

Figure 105. Channel width and bed elevation at the crossing near Magnolia.

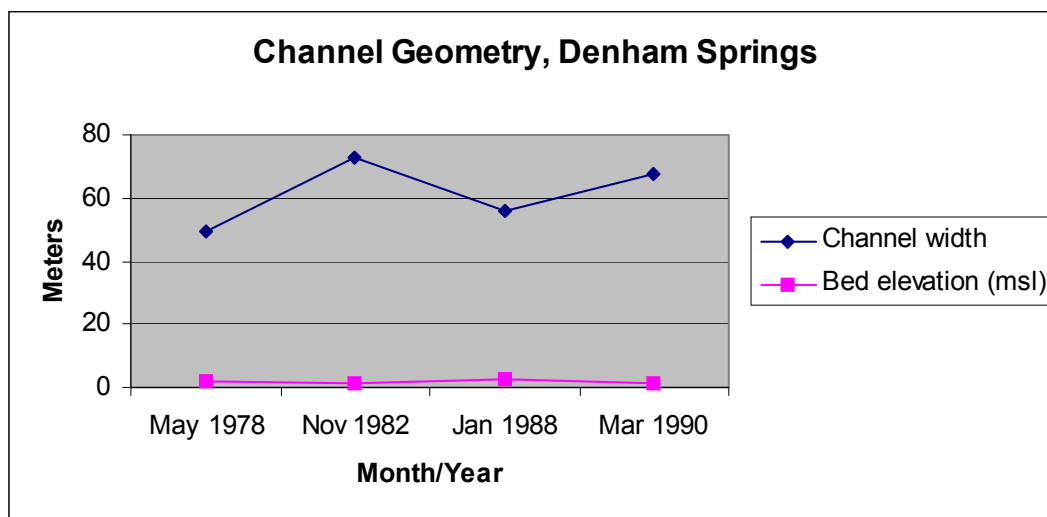
Figure 106. Channel width and bed elevation at the Denham Springs crossing.

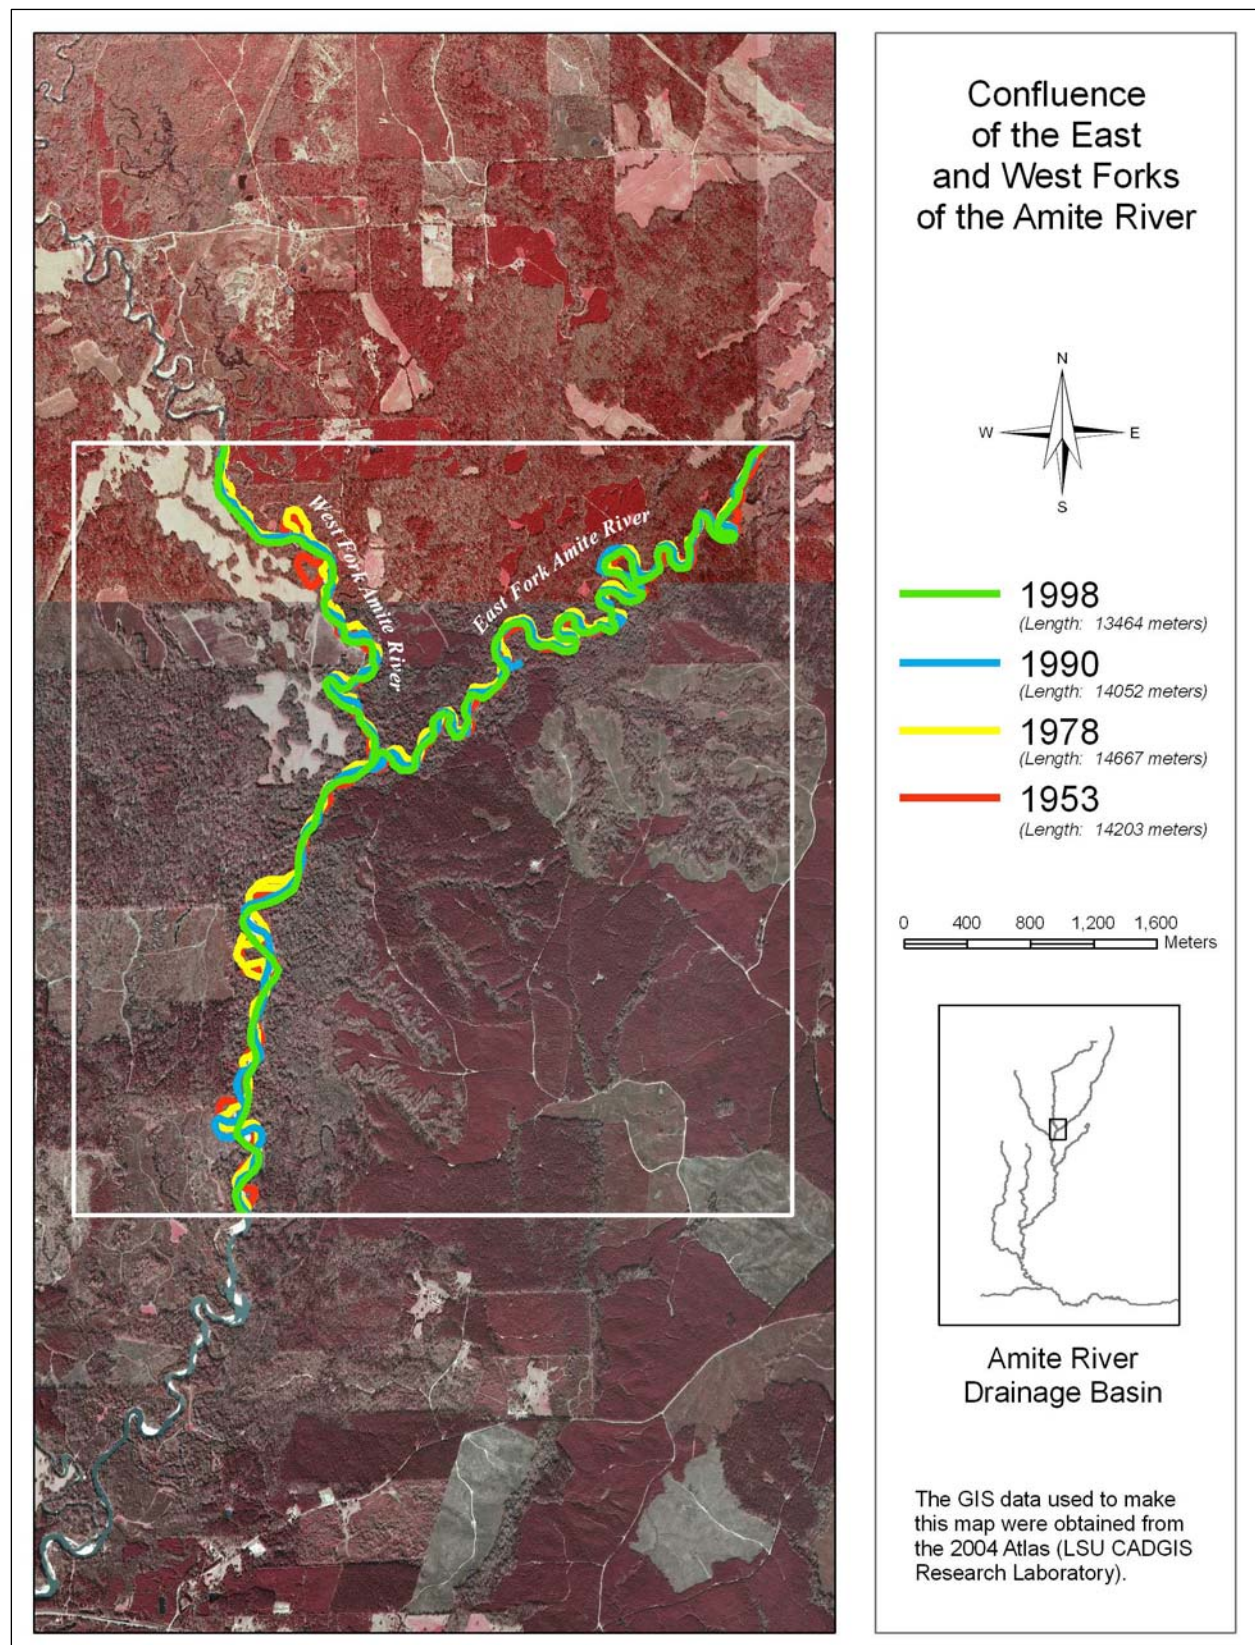
channel. Although the stream channel was locally straightened, the bankline still appears to be well-vegetated in the 1998 photo. By 1998, there is less forest cover as indicated by the areas of lighter phototone. The changes in stream plan form along this reach is shown in Figure 108.

Figure 108. Changes in stream planform between 1953 and 1998.

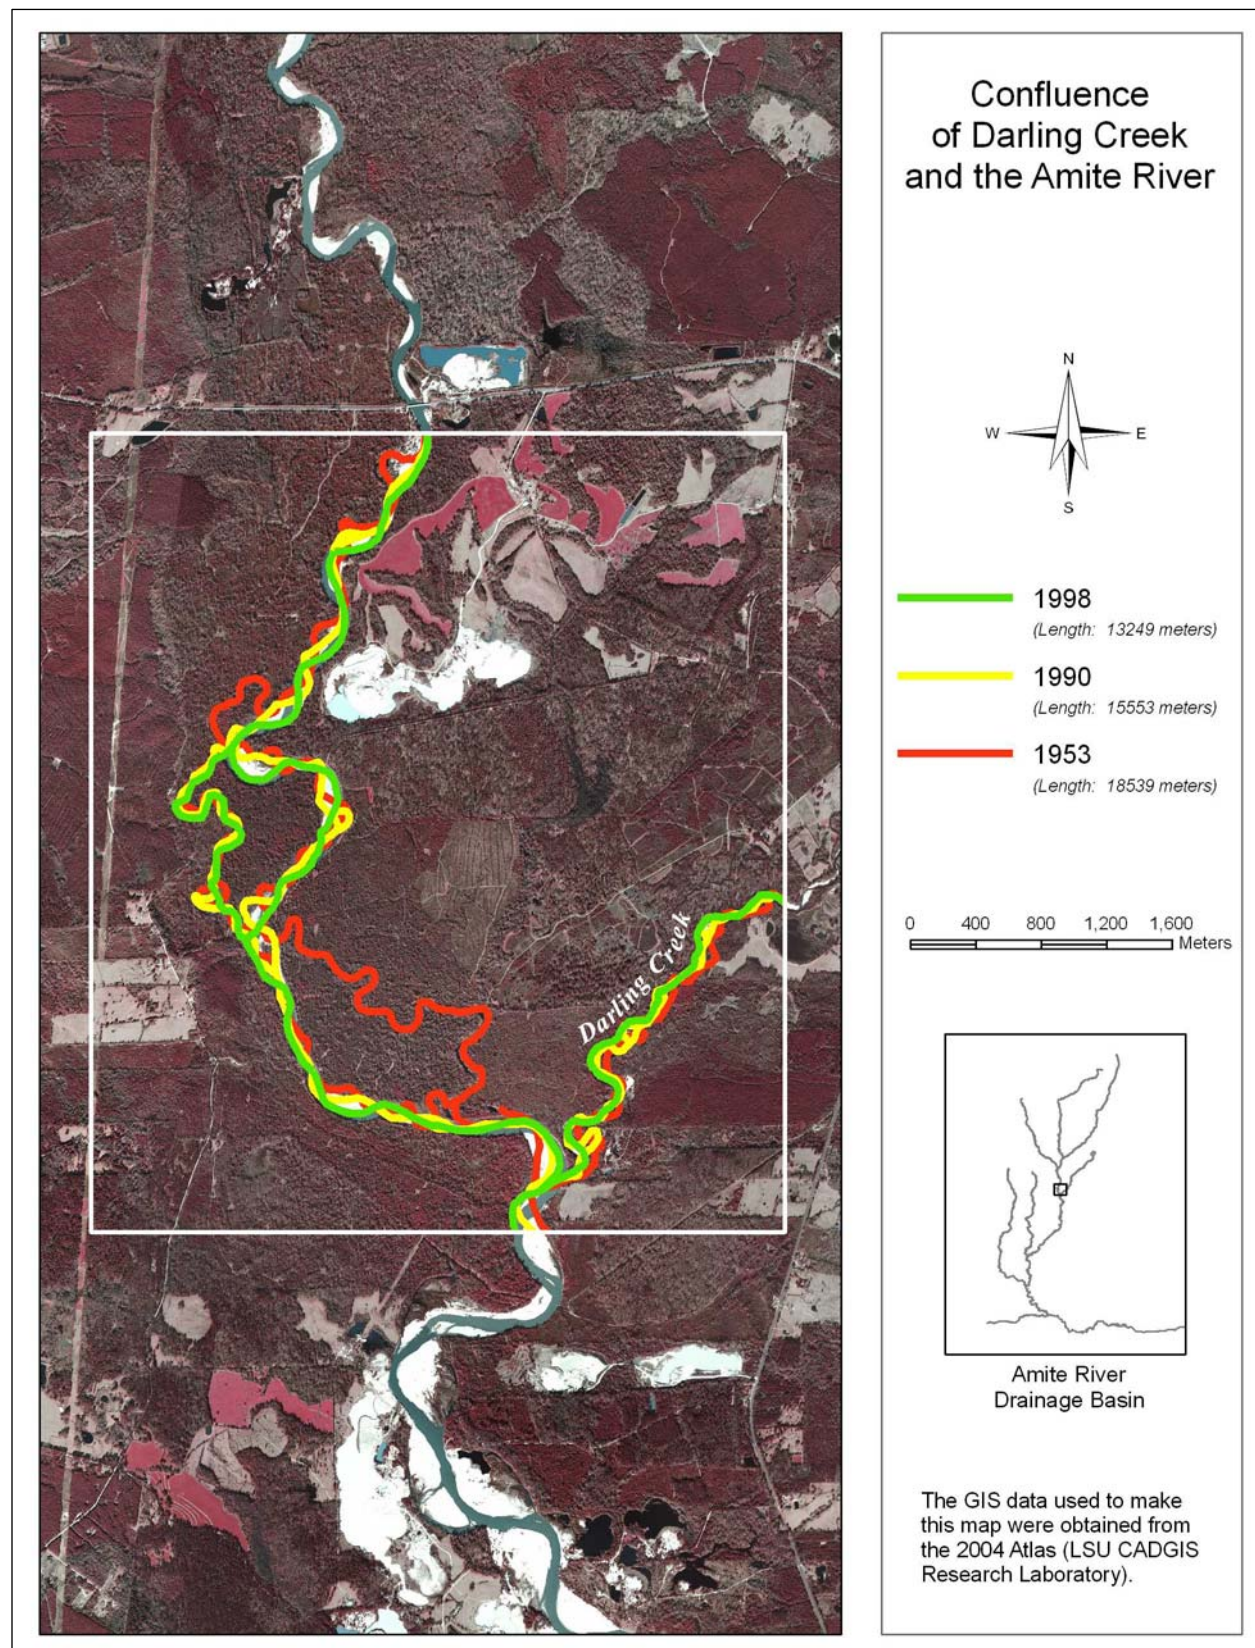
extended downstream approximately 0.8 km upstream of the confluence. The two channels are the West Prong and East Prong of the Amite River. The 1998 photograph showed that bifurcation was present; however, most of the East Prong had been abandoned. The 1998 photograph also indicated larger and more extensive point bar development and less forest/more cleared areas. Planform changes are shown in Figure 110.

Figure 110. Changes in planform in vicinity of Darling Creek confluence between 1953 and 1998.

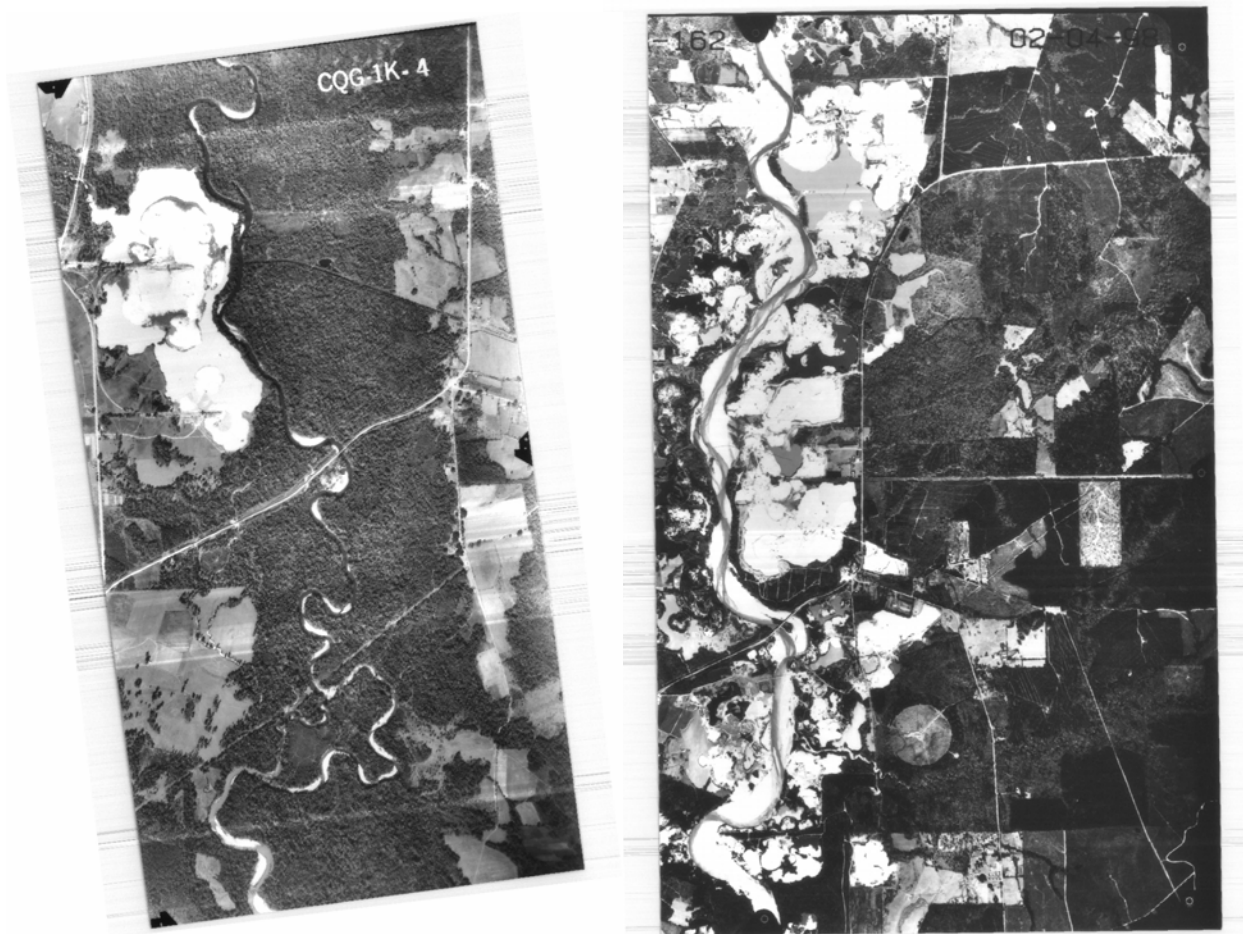
The 1953 and 1998 aerial photographs of the Louisiana Highway 37 crossing of the Amite River near Grangeville, LA, are shown in Figure 111. The Louisiana Highway 37 crossing is represented by “a” in the photos. In the 1953 photograph, the stream appears to be sinuous with good bar development and well vegetated banks. On the right bank, a large floodplain gravel mine is apparent in the 1953 photo, upstream of the Louisiana Highway 37 crossing. There appears to be a riparian buffer zone between this mine and the Amite River channel. No mines are present in this view downstream of the crossing. The 1953 photograph shows bank-line vegetation, absence of divided flow, and point bar development. The 1953 photograph shows a pipeline crossing the river approximately 1.7 km downstream of the crossing. The 1953 photograph shows bank-line

Figure 111. 1953 and 1998 aerial photography of the Louisiana Hwy 37 crossing of the Amite River near Grangeville, LA.

vegetation, absence of divided flow, and point bar development. The 1953 photograph shows a pipeline crossing the river approximately 1.7 km downstream of the bridge. Near the pipeline crossing, there is evidence of bifurcation and a short reach of divided flow. The 1998 photograph exhibits extensive mining on both sides of the river, channel widening and straightening, loss of bank-line vegetation and divided flow. The bridge appears to cross a dry area of the channel as noted in the previous section on the field studies. Planform changes along this reach are shown in Figure 112.

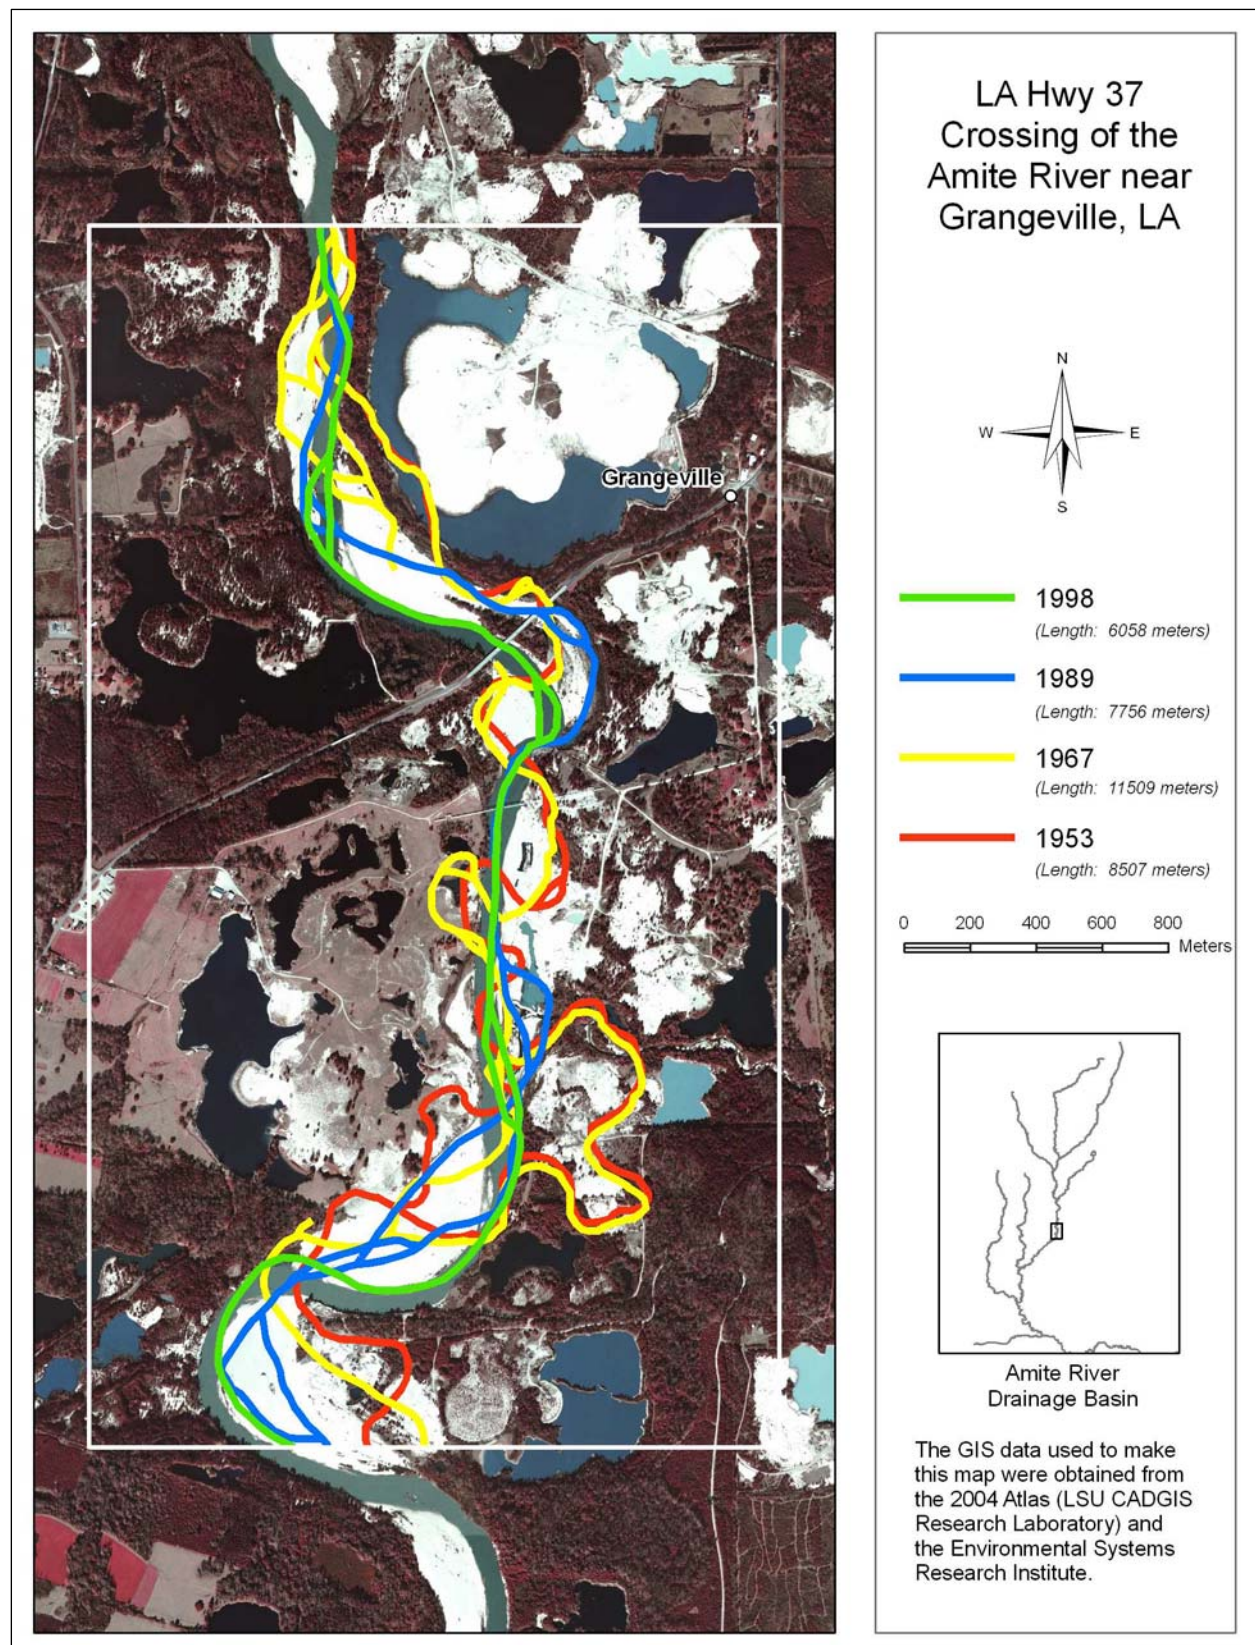
Figure 112. Planform change between 1953 and 1998 along the Grangeville Reach.

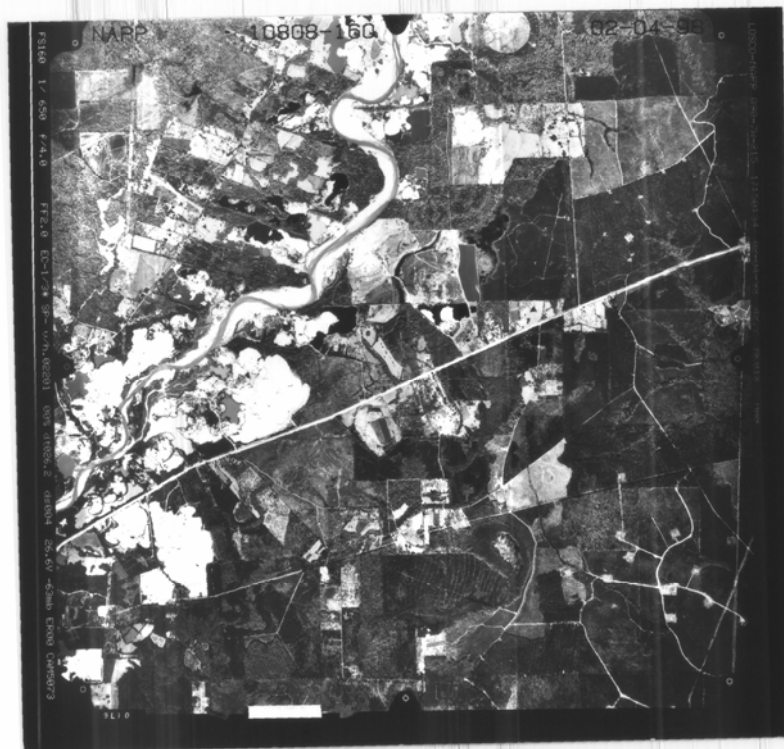
Figure 113 is the 1953 and 1998 photographs of the Amite River further downstream of the Louisiana Highway 37 crossing near Grangeville, LA. The roughly east-west highway in the lower right corner of the 1998 photograph is Louisiana Highway 16. In the 1953 photograph, there are several small mined areas along the lower reaches and the channel appears

stable with a meandering configuration, good bar development, and well-established bank-line vegetation. In the 1998 photograph, numerous large mines are evident on both sides of the channel. It is apparent that severe channel widening and straightening has occurred along with divided flow and loss of bank-line vegetation. Planform changes are shown in Figure 114.

Figure 113. 1953 (a) and 1998 (b) photographs of the Amite River downstream of the views presented in Figure 111.

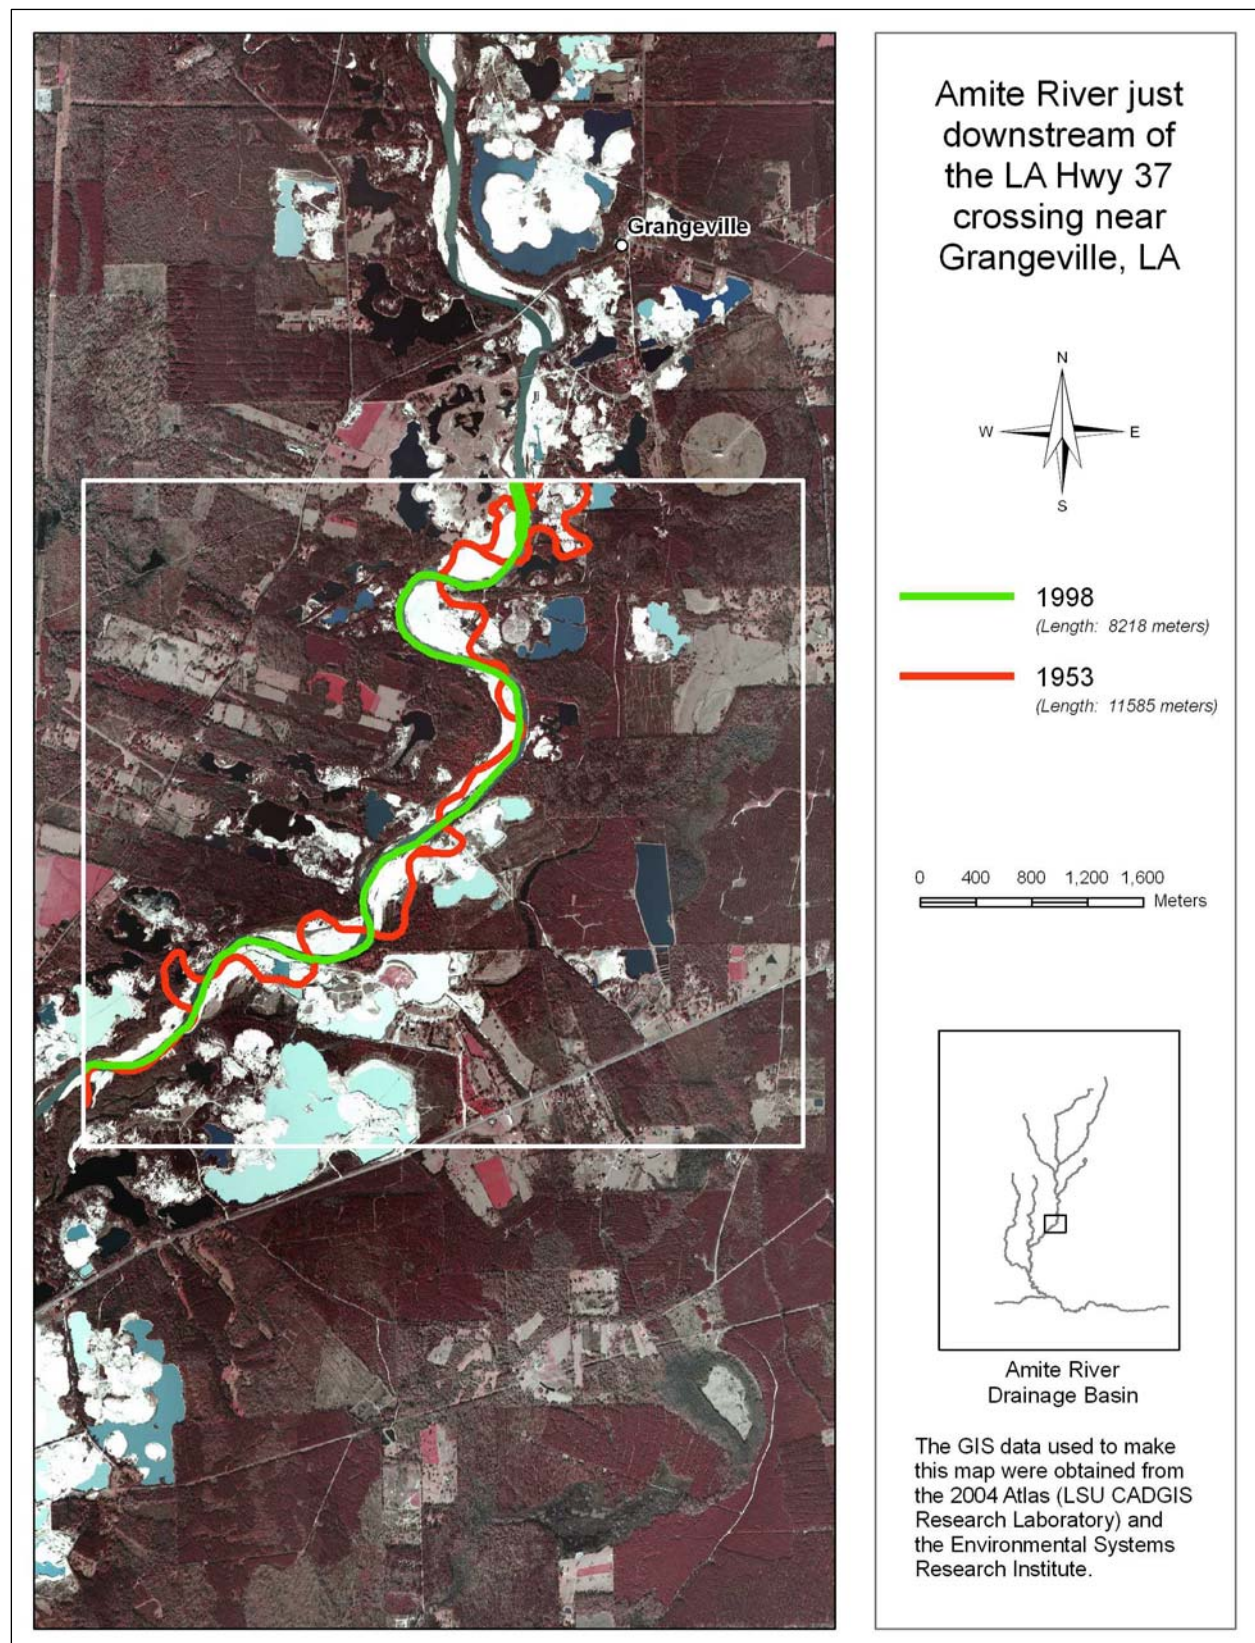
Figure 114. Planform changes south of Grangeville downstream of the Louisiana Highway 37 crossing between 1953 and 1998.

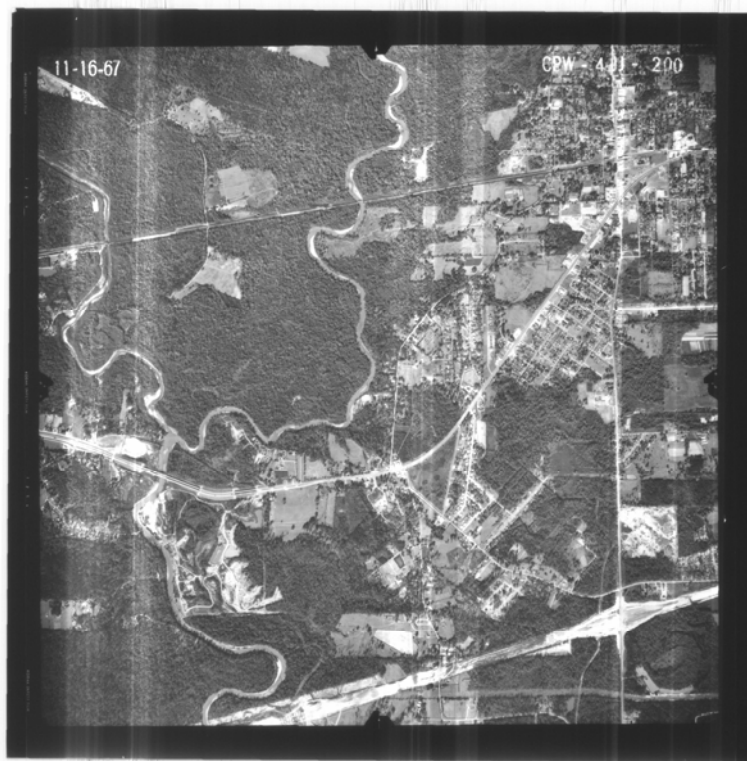
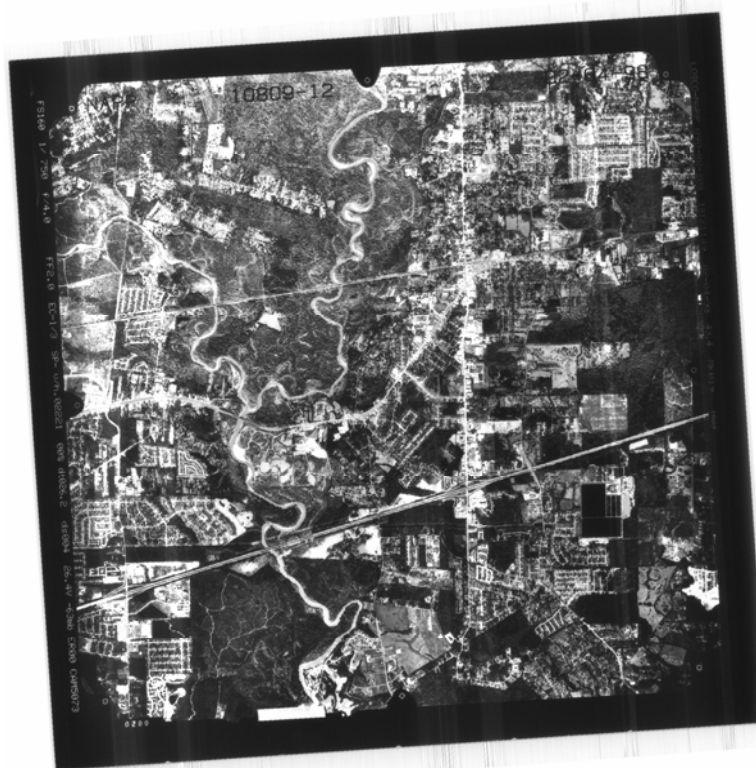
The convergence of these rivers lies approximately 30 m upstream of the Louisiana Highway 190 crossing of the Amite River near Denham Springs, LA. Figure 115 shows the 1967 (a) and 1998 (b) photographs of this reach, which is downstream of the mined reaches. The highway in the lower part of both views is I-12 and the next crossing to the north of I-12 is Louisiana Highway 190. The Comite River can be seen entering the Amite River from the west. The 1967 and 1998 views show that the Amite River exhibits bank-line vegetation, a sinuous channel, and absence of significant point bar development. The 1998 photograph shows significant land-use changes since 1967 due to urbanization in the Baton Rouge (west) and Denham Springs (east) areas. Planform changes are shown in Figure 116.

Figure 115. 1967 (a) and 1998 (b) photographs of the Amite and Comite rivers and the I-12 and Louisiana Highway 190 crossings.

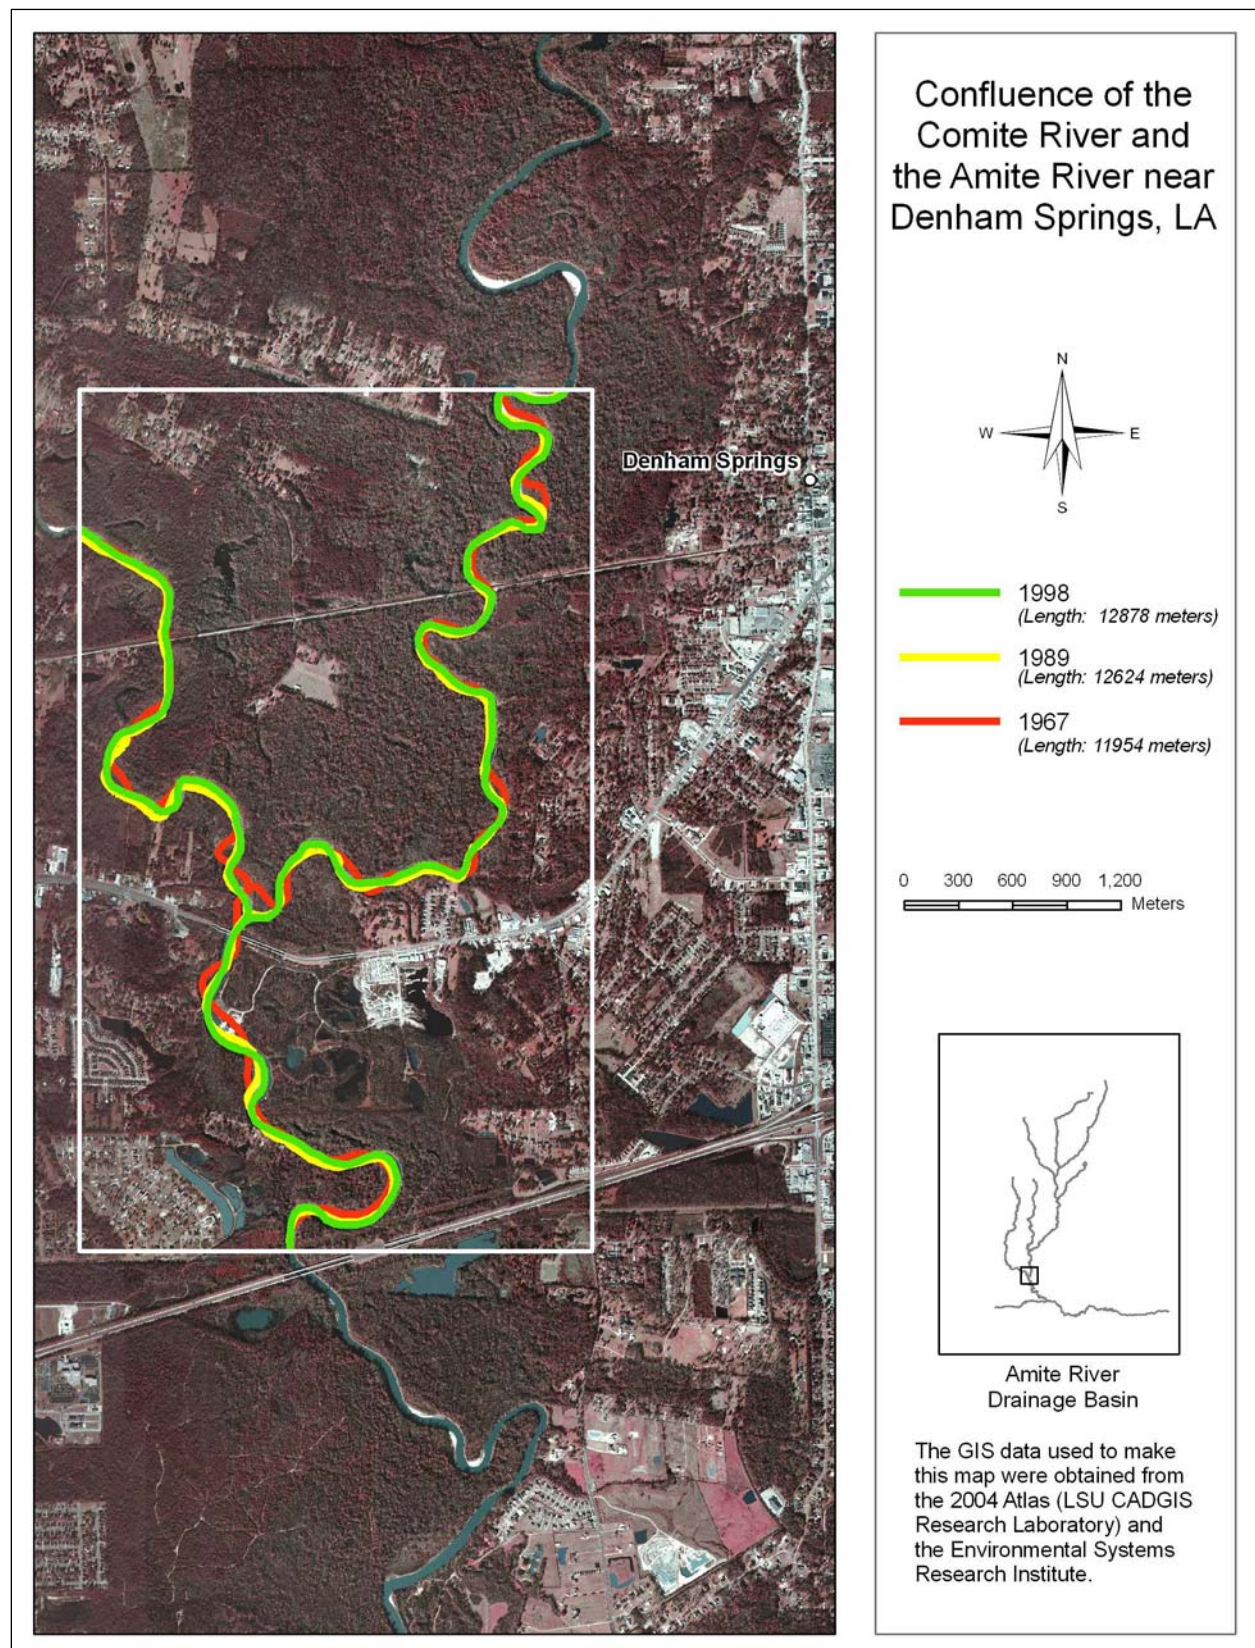
Figure 116. Planform changes in the vicinity of confluence of the Amite and Comite rivers between 1967 and 1998.

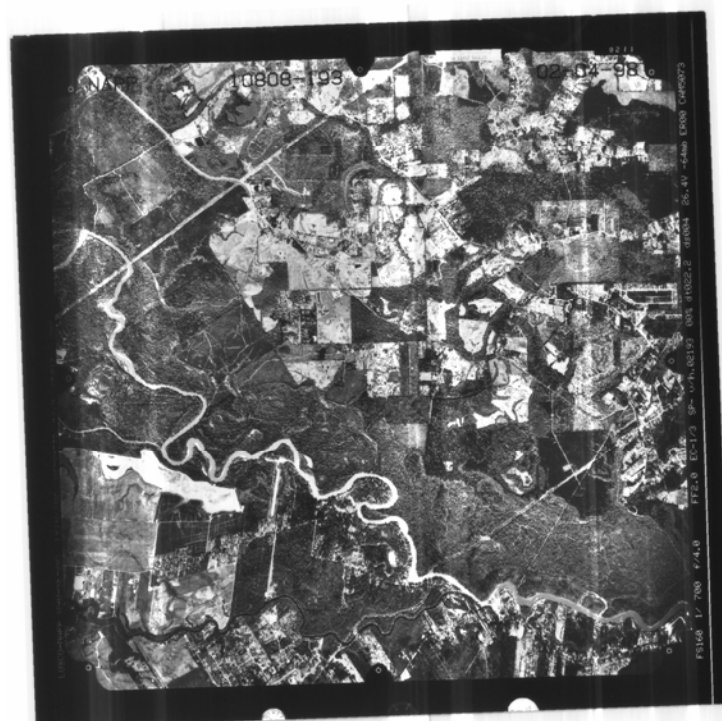
Figure 117 is 1953 (a) and 1998 (b) aerial photographs of a portion of the lower reaches of the Amite River, including the confluence of the Amite River with Bayou Manchac. This particular portion of the Lower Amite River is located approximately 7 km upstream of Port Vincent, LA. Horseshoe Bend, a well known natural landmark in this area, is found at the lower right corner of the 1953 photograph and it is the major reference feature on both the 1953 and 1998 views. The additional linear reference features seen in the 1998 view are the power transmission line in the north and the pipeline crossing downstream of Horseshoe Bend. Bayou Manchac enters the Amite River from the west downstream of the pipeline crossing. The Amite River in the 1953 view appears stable with well vegetated banks and minor point bar development. The channel in the 1998 view also appears stable; however, the reach is more urbanized. Planform changes are shown in Figure 118.

Figure 117. 1953 (a) and 1998 (b) aerial photographs of the Amite River reach approximately 7 km upstream of Port Vincent, LA. The prominent meander bend (Horseshoe Bend) is apparent in both views. Two crossings are shown in the 1998 view, a power transmission line to the north and a pipeline to the south of Horseshoe Bend. Bayou Manchac enters the Amite River from the west a short distance downstream of the pipeline crossing.

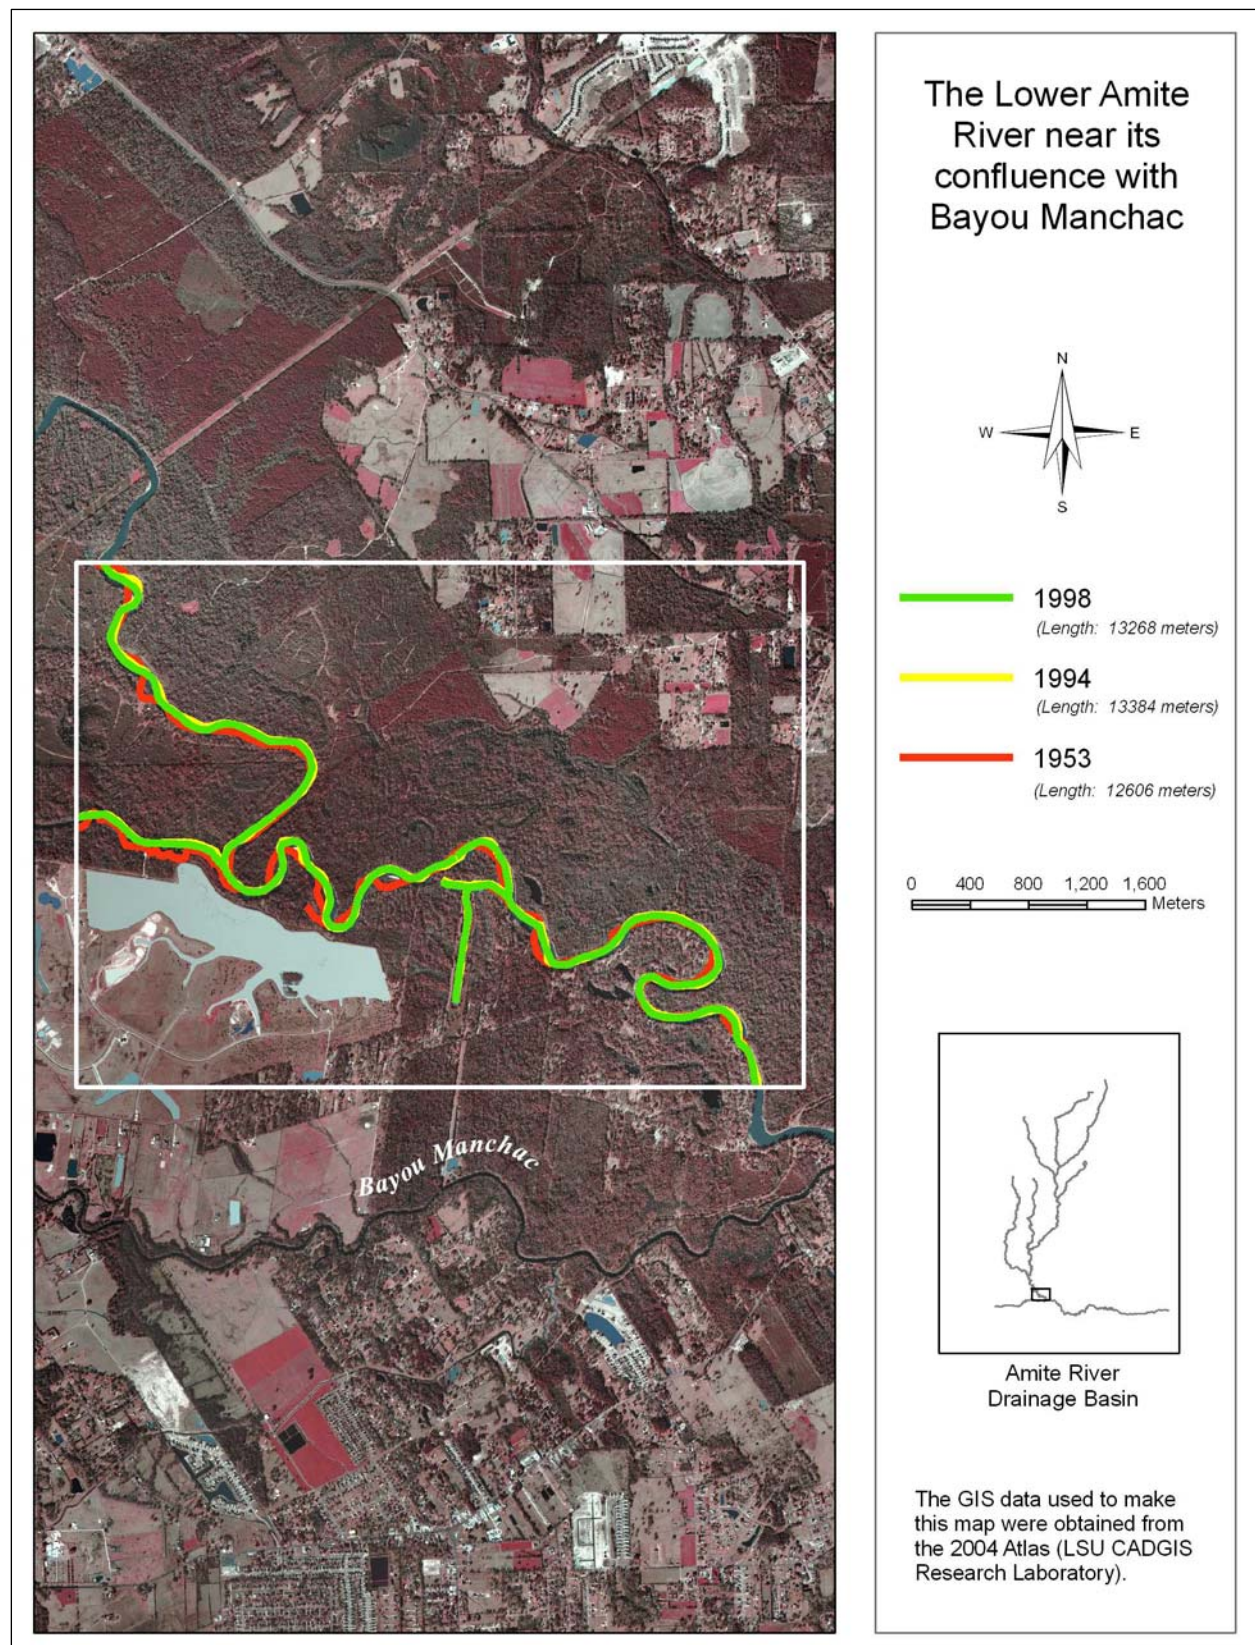
Figure 118. Planform changes in the vicinity of Bayou Manchac between 1953 and 1998.

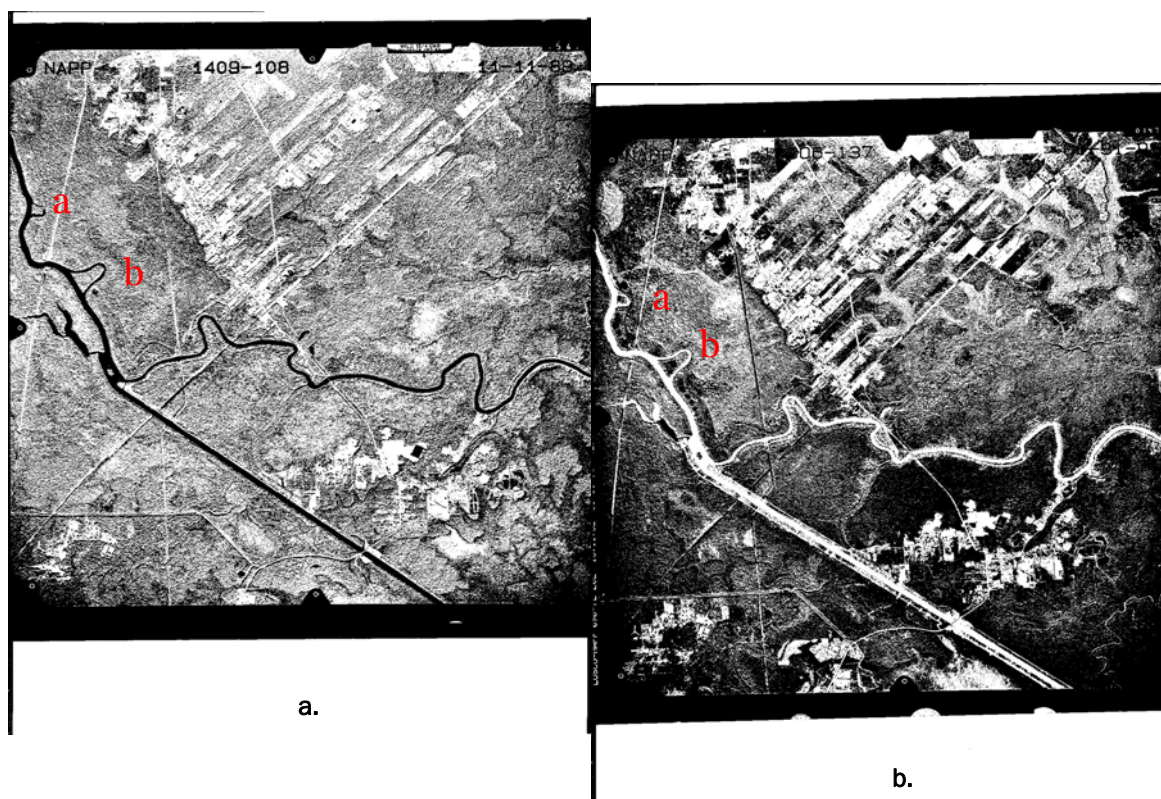
Figure 120 depicts 1989 (a) and 1998 (b) aerial photographs of the Amite River Diversion Canal where it bisects the Amite River a few kilometers south of Port Vincent, LA. No aerial photography was available prior to 1989. The canal was built between 1957 and 1964 for the purpose of flood-control by diversion of floodwaters from the Amite River directly to Lake Maurepas. The aerial photographs show two meander cutoffs, which were probably constructed as a part of the diversion project. There does not appear to be significant change in channel planform nor land-use between 1989 and 1998 as indicated in Figures 120 and 121.

Figure 120. 1989 (a) and 1998 (b) aerial photographs of the Amite River Diversion Canal downstream of Port Vincent, LA (note points “a” and “b” are common points and major meander cutoffs).

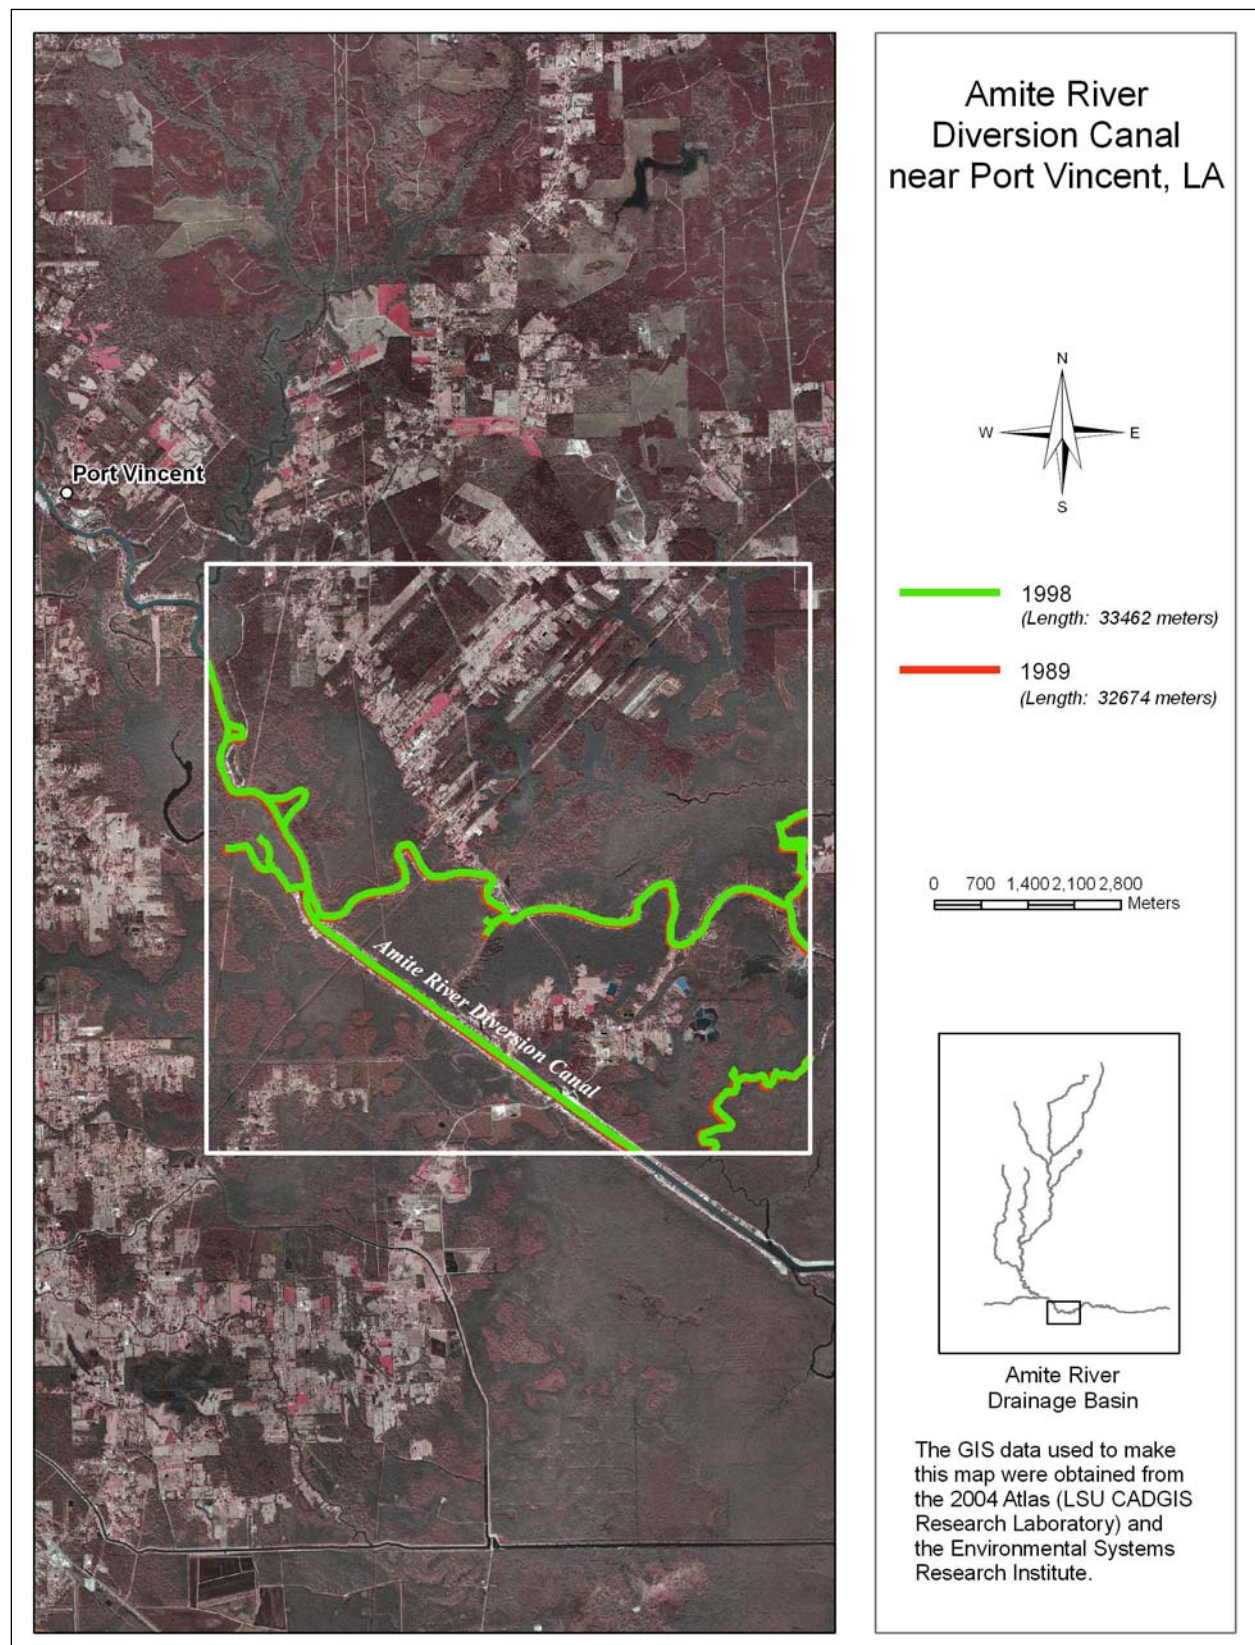
Figure 121. Planform changes in vicinity of Amite River Diversion Canal between 1989 and 1998.
